Owner & Agent Training

Physical Inspection Standards: Mastering Physical Inspections

Presented by: Jose Zavala, *Physical Inspector*

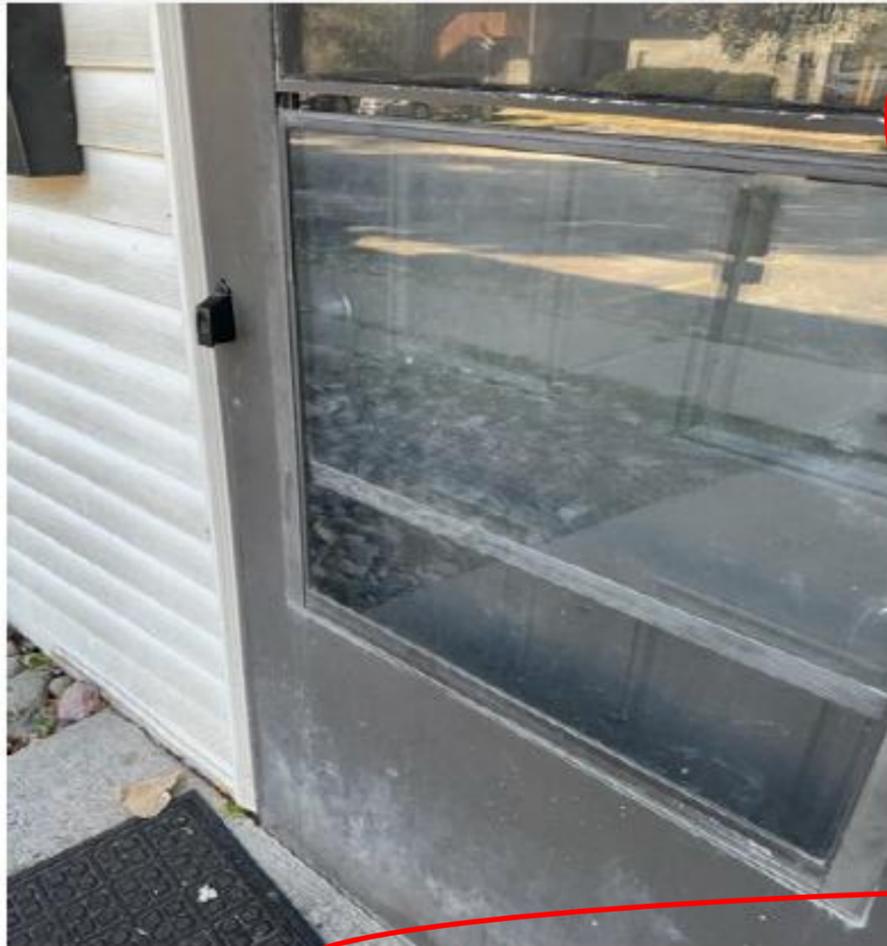
49

00130 Unit 7-129 - Alternate Location - See Notes for Details - Door Hardware - Entry (non-fire) - Oct 23 2025 2:52PM - J Zavala CAPTION: Storm door in front of unit 129 handle is broken and will not close or self latch

Location	Item	Results	Notes	Pic	Date	Fixed	Sev	Fix By
Alternate Location - See Notes for Details	Door Hardware - Entry (non-fire)	Entry door component is damaged, inoperable, or missing (does not affect privacy or security) (17263)	Storm door in front of unit 129 handle is broken and will not close or self latch	<u>49</u>	10/23/25 14:52 JZ		Low	60D
Hallways & Corridors	Ceiling Covering and Finishes	Ceiling component(s) is not functionally adequate (17235)	Mold like substance on ceiling and hallway above mechanical closet- peeling paint	<u>50</u>	10/23/25 14:48 JZ	X	Severe	24H
Storage Room	Infestation	Evidence of mice (17286)	Mice droppings located in mechanical room on top of hot water tank and floor	<u>51</u>	10/23/25 14:50 JZ		Mod	30D

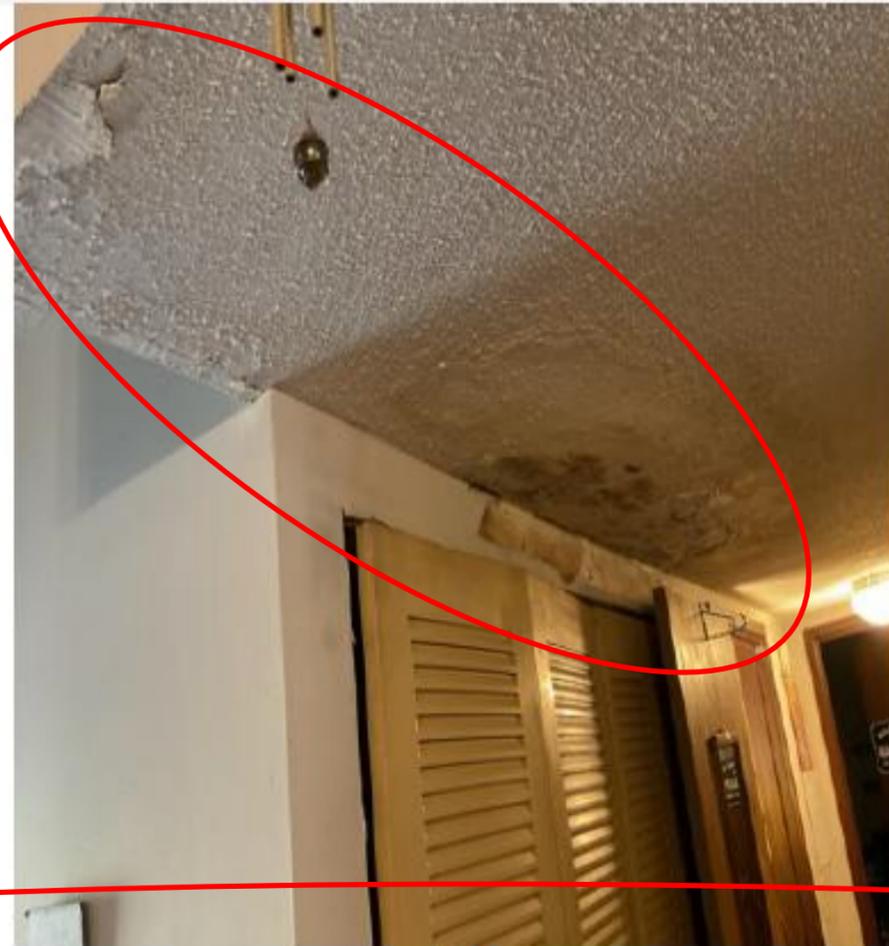
50

00130 Unit 7-129 - Hallways & Corridors - Ceiling Covering and Finishes - Oct 23 2025 2:48PM - J Zavala CAPTION: Mold like substance on ceiling and hallway above mechanical closet- peeling paint

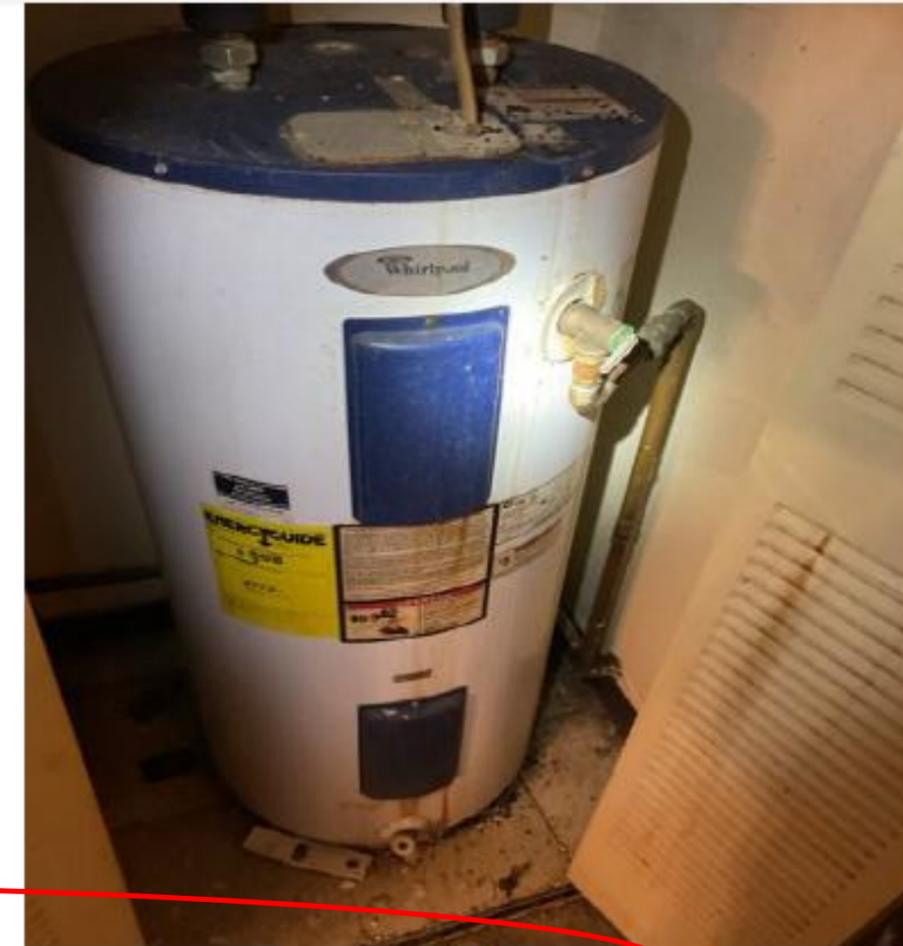
51

00130 Unit 7-129 - Storage Room - Infestation - Oct 23 2025 2:50PM - J Zavala CAPTION: Mice droppings located in mechanical room on top of hot water tank and floor

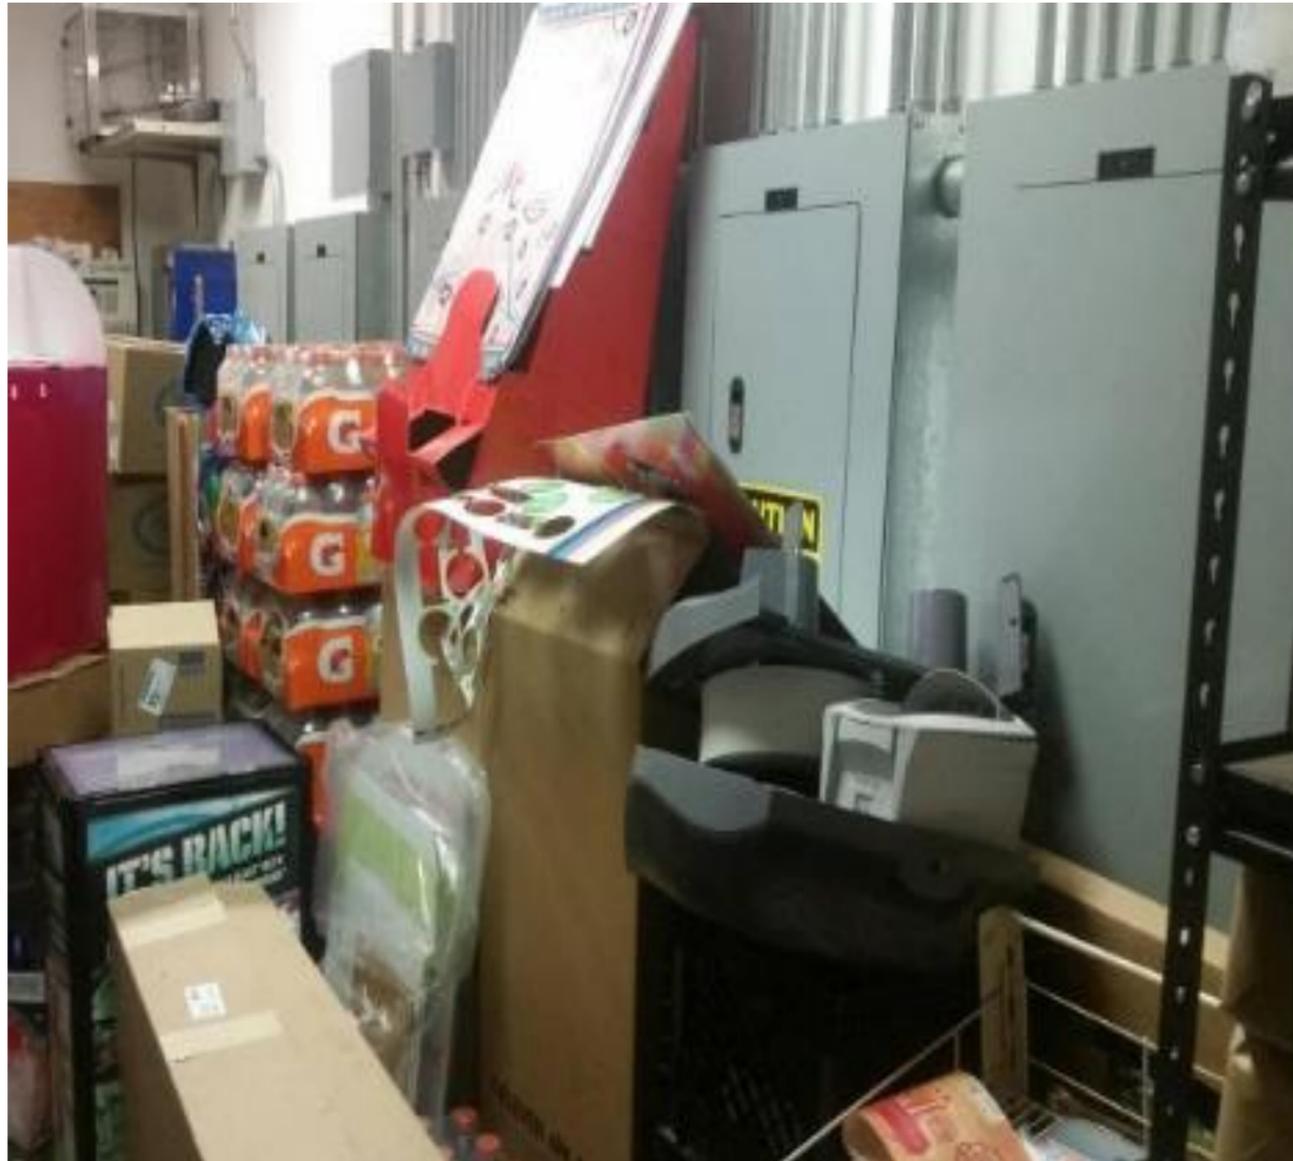
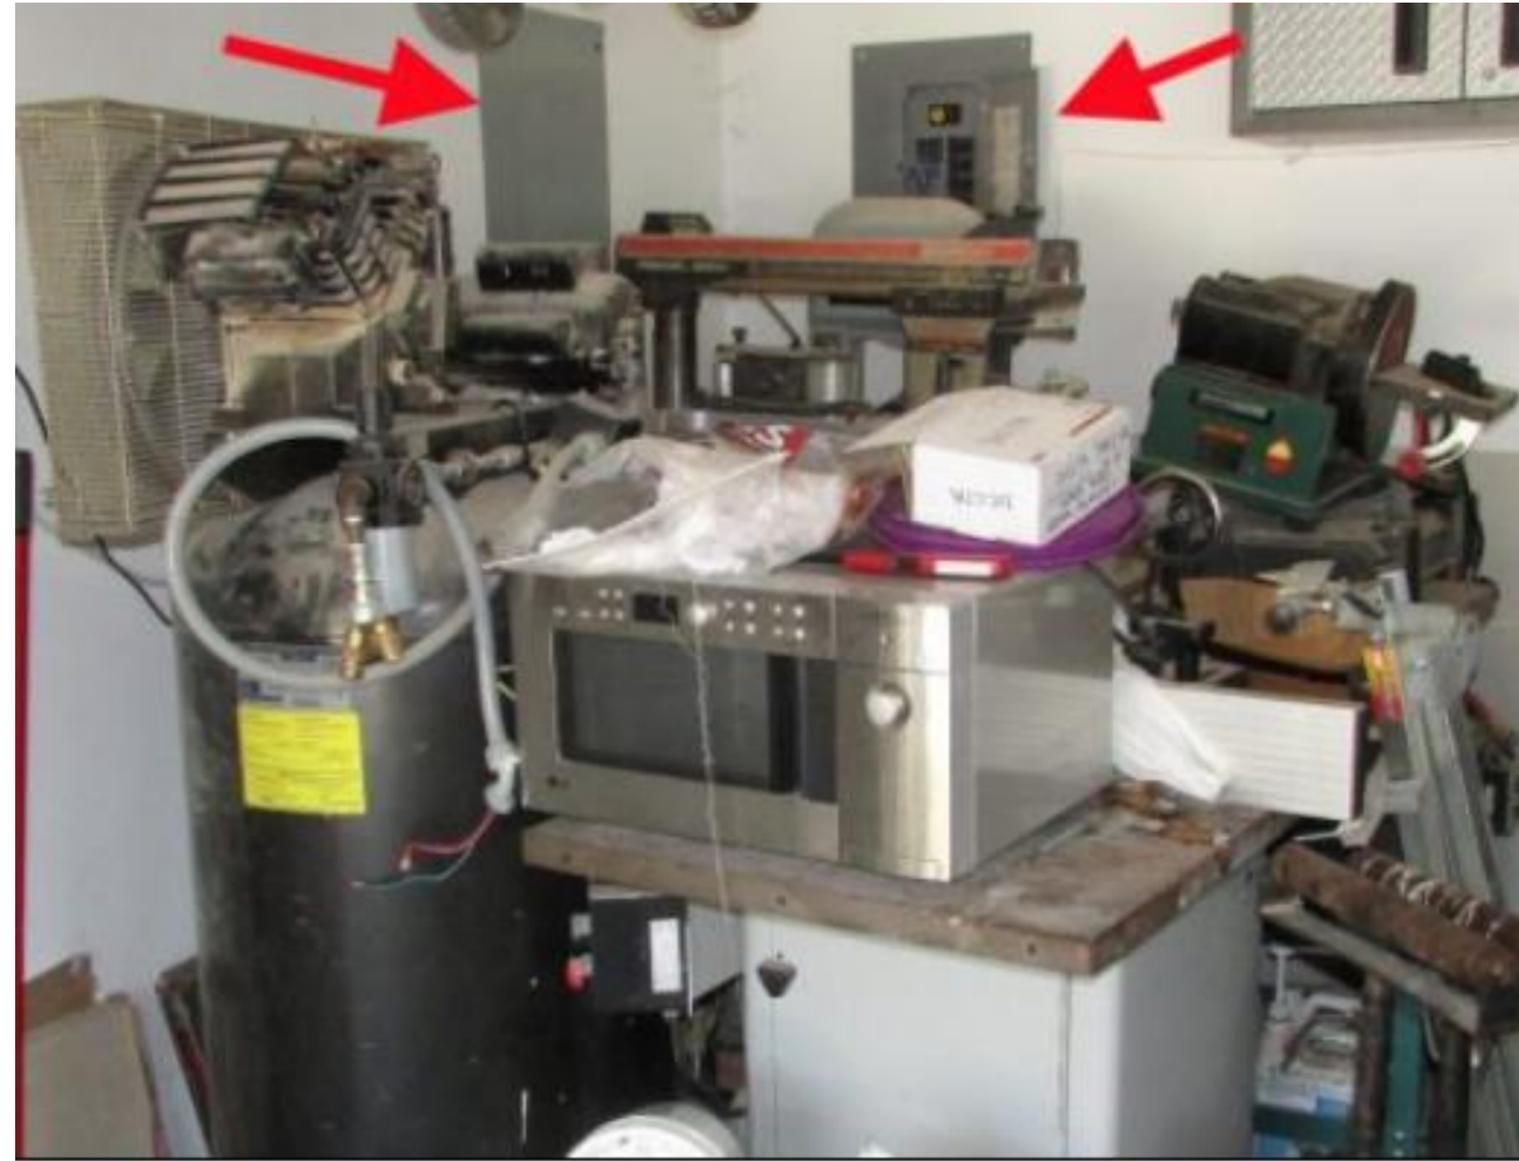
Electrical service panel is not readily accessible. In case of emergency.

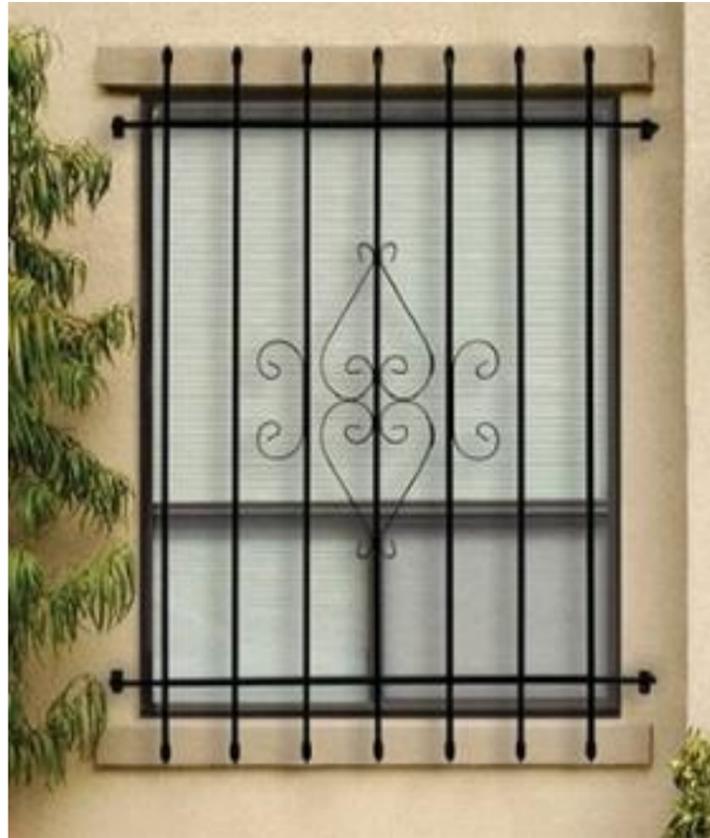
Windows with stationary security bars are unacceptable under NSPIRE and UPCS standards.

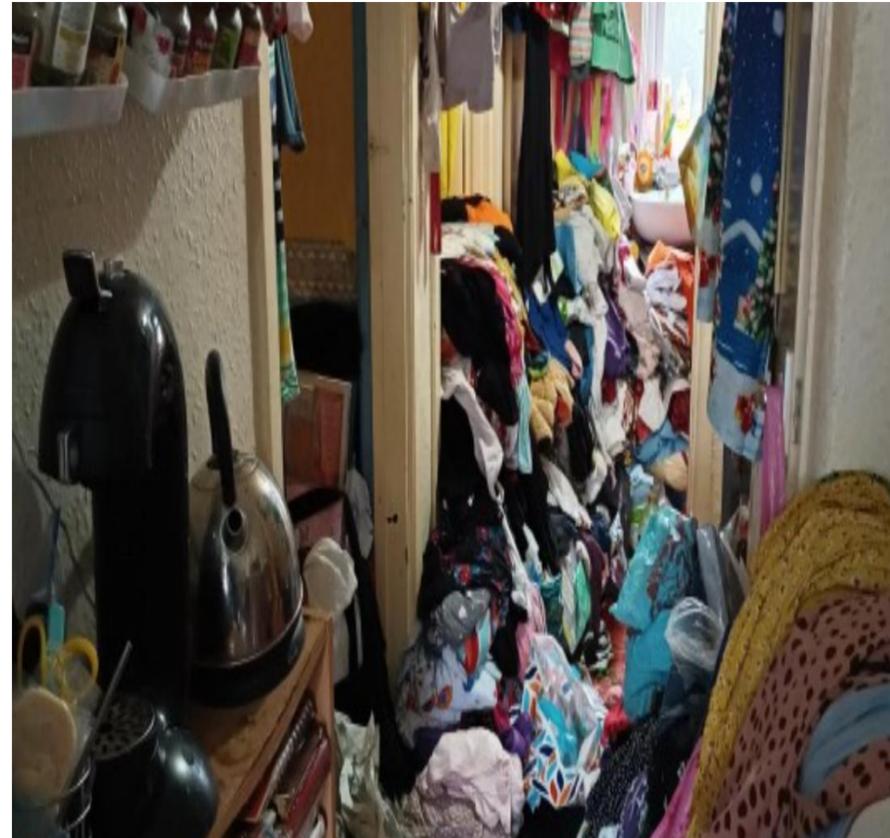
Excessive clutter blocks all emergency evacuations for example EMT service. NSPIRE and UPCS standards require an exit access to serve as is a path from any interior location to an exit.

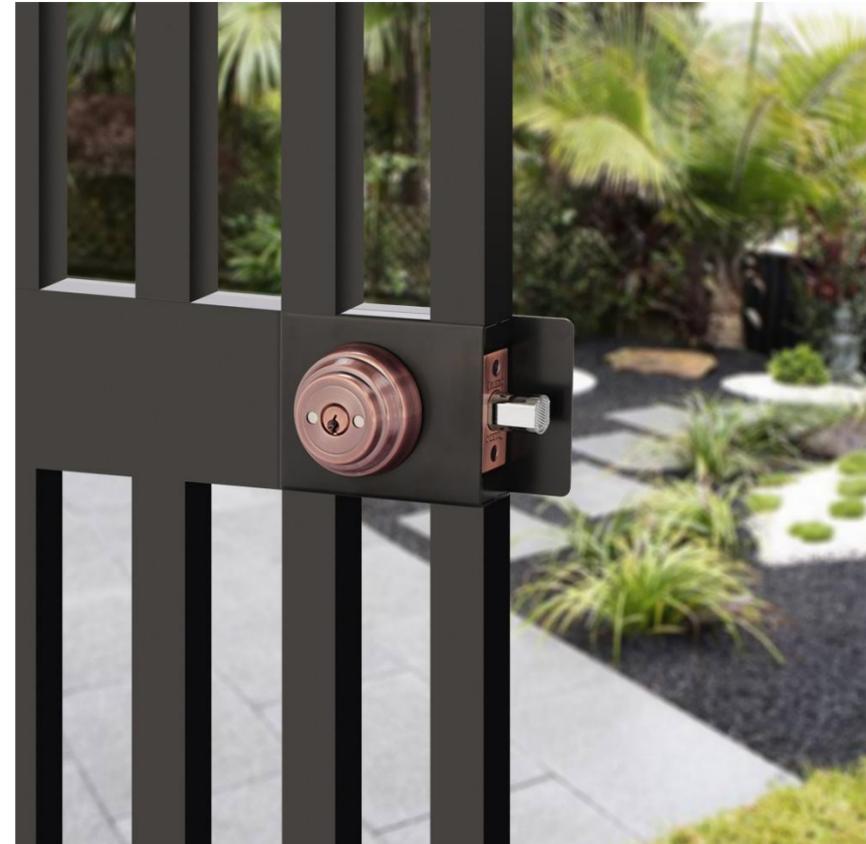
NSPIRE does not allow a keyed exterior gate, or fence. It is considered a condition that may obstruct the means of egress.
